Fluids Team:

Daniel and Andy's never-ending quest to stop oil leaks.

- objectives: Solving the leaking problem of the '63 triumph
- take apart timing side to investigate
- solve any existing problems and observe the oil system

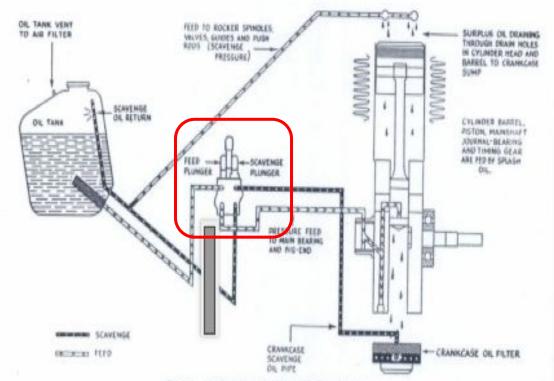
Fig. 2. ENGINE LUBRICATION DIAGRAM

Triumph Oil system:

-constant
lubrication
through 2 lines

Feed plunger: sends oil to the head as well as the crankshaft

Scavenge plunger: Returns oil back to the tank.

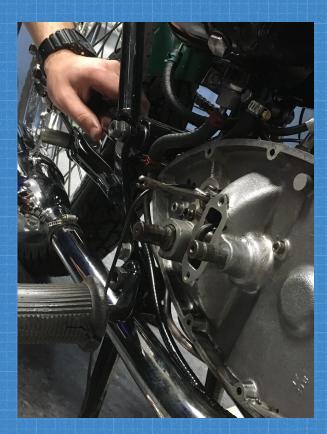
Initial Concerns: The Outer Timing Cover

- Leaking that reached the outer timing cover when opened (big no-no).

- Oil was already drained prior to opening cover

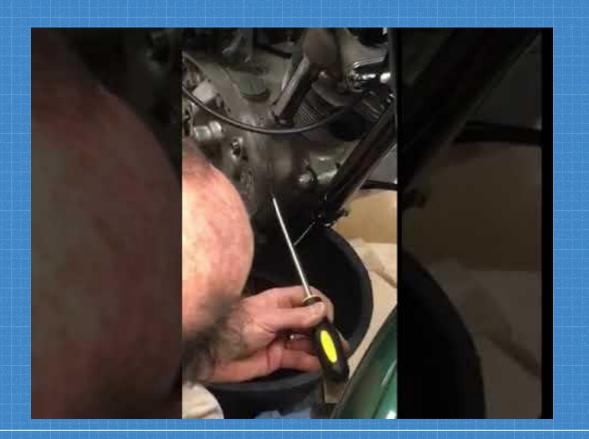
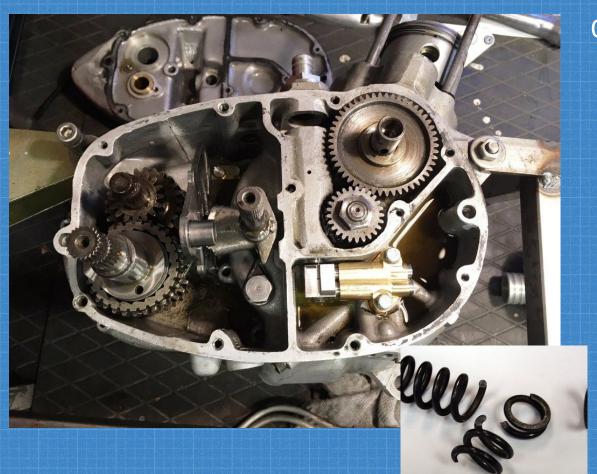
The Push Forward: Surpassing the Inner Timing Cover

Risqué techniques employed (troubles getting Tri-Bond off)

Professor Littman's finessé enables us to take off cover easily

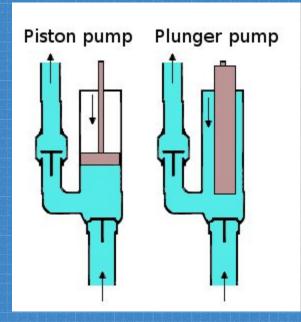
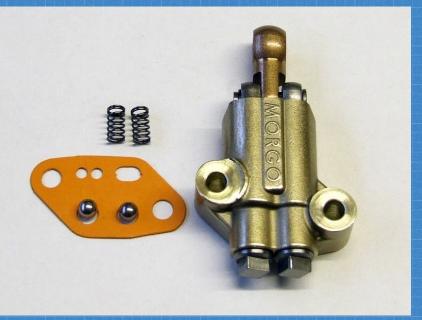
Oil Pump Problems:

- Previous group failed to properly tighten oil pump
- Attention was not brought to broken spring
